REPORT OF FINDINGS

LEVEL I ENVIRONMENTAL SITE ASSESSMENT

CARSON OIL COMPANY

PORTLAND, OREGON

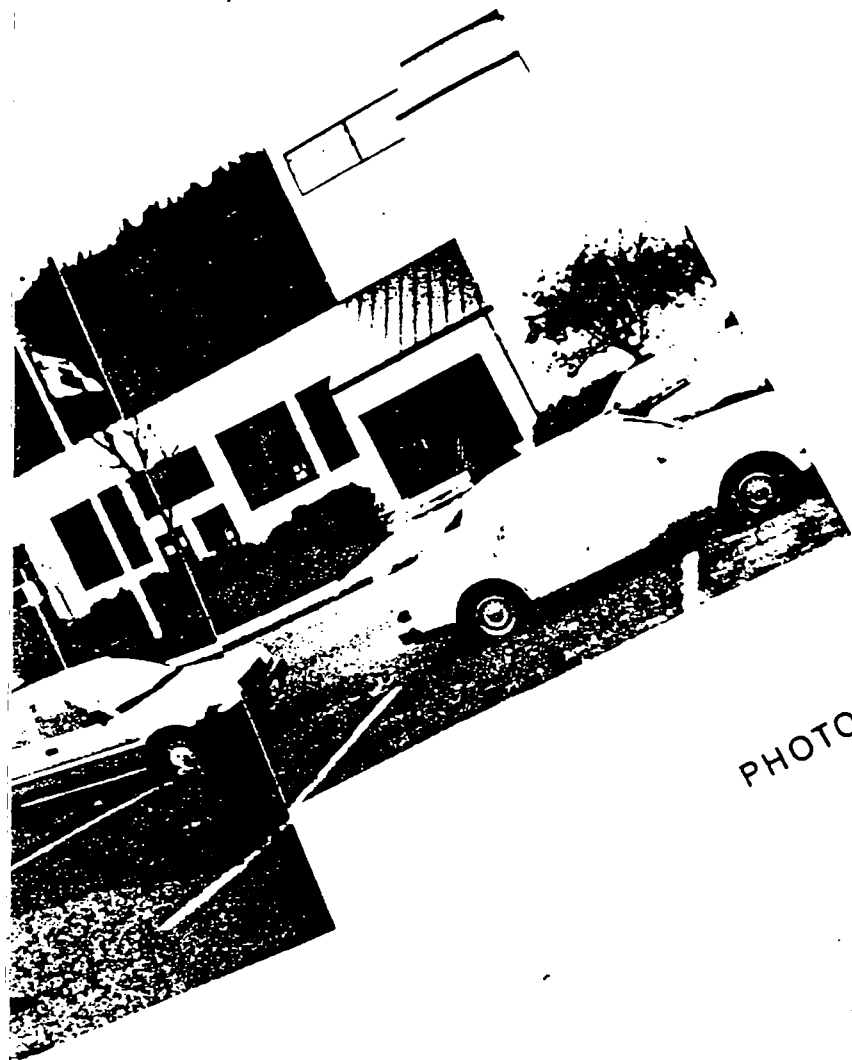
PHOTO 2

- 1-3) Panorama looking to the west across NW 35th Avenue. The office area of Columbia American Plating (CAP) is located beyond the utility poles in photo 1. The main building on the subject property is in all three photos. The oil warehouse area is the single story portion of the building to the left. The cardlock fuel island is to the extreme right of photo 3.

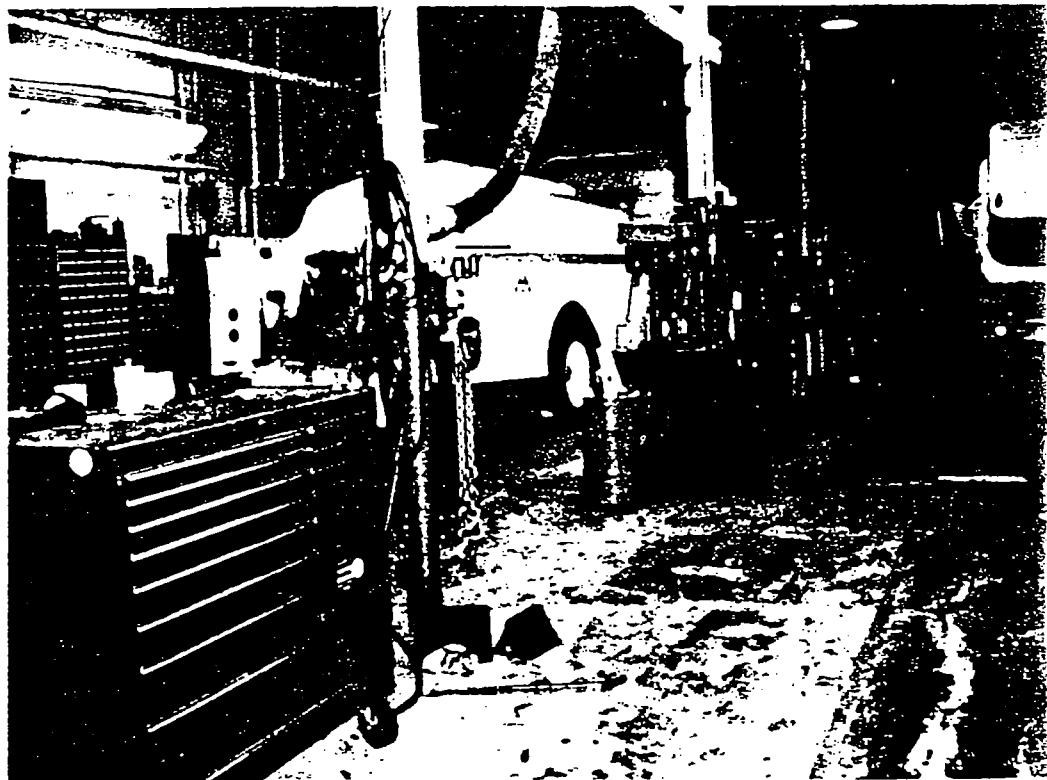
PHOTO 10

- 10-11) Photo looking south. The interior of the vehicle maintenance area. Note the small solvent tank in the lower right hand corner of photo 11.
- 13) Photo looking south. The northern elevation of part of the CAP property. The CAP waste water treatment unit is located in the plywood shelter on the side of the plating building. The hazardous waste "containment area" is located to the north and east of the treatment unit. Many of the drums lining the fence on the CAP property contain hazardous waste.

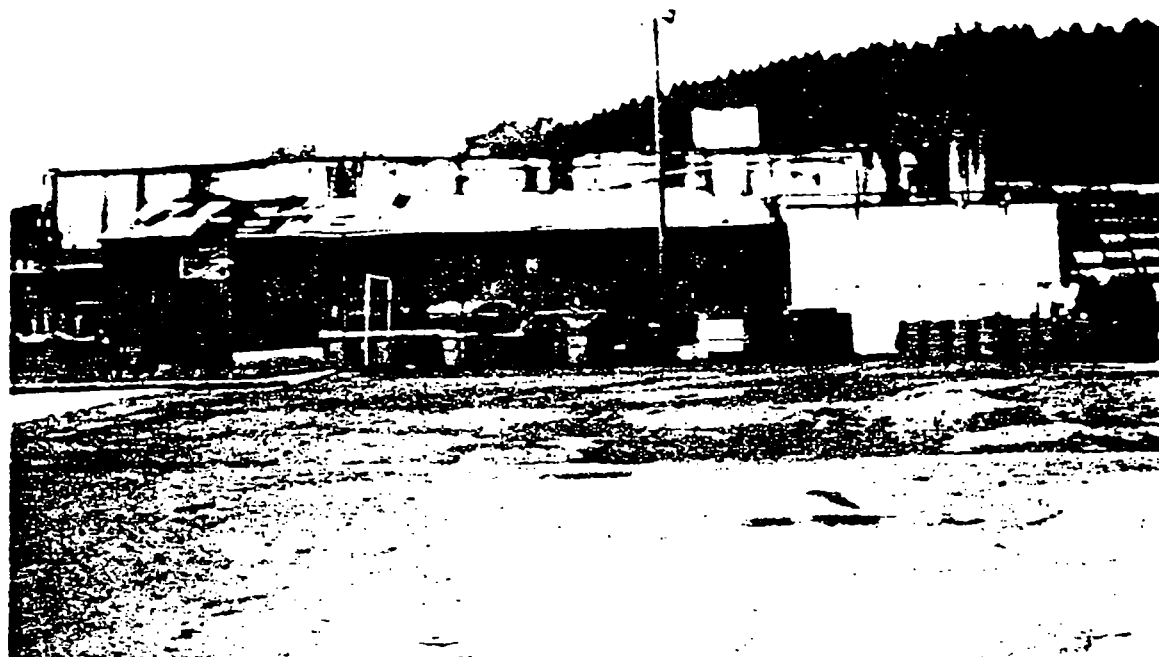
PHOTO 13

The hazardous waste containment area and waste water containment unit are located on the north side of the CAP property. They are separated from the subject property by a chain link fence. Wastes stored in the containment area include solutions containing cyanide and various heavy metals. During the visit to the subject property, Century West personnel noted drums labeled "hazardous waste" located on the CAP property immediately next to the fence separating the two properties (refer to photos 13 and 14 in Appendix C).

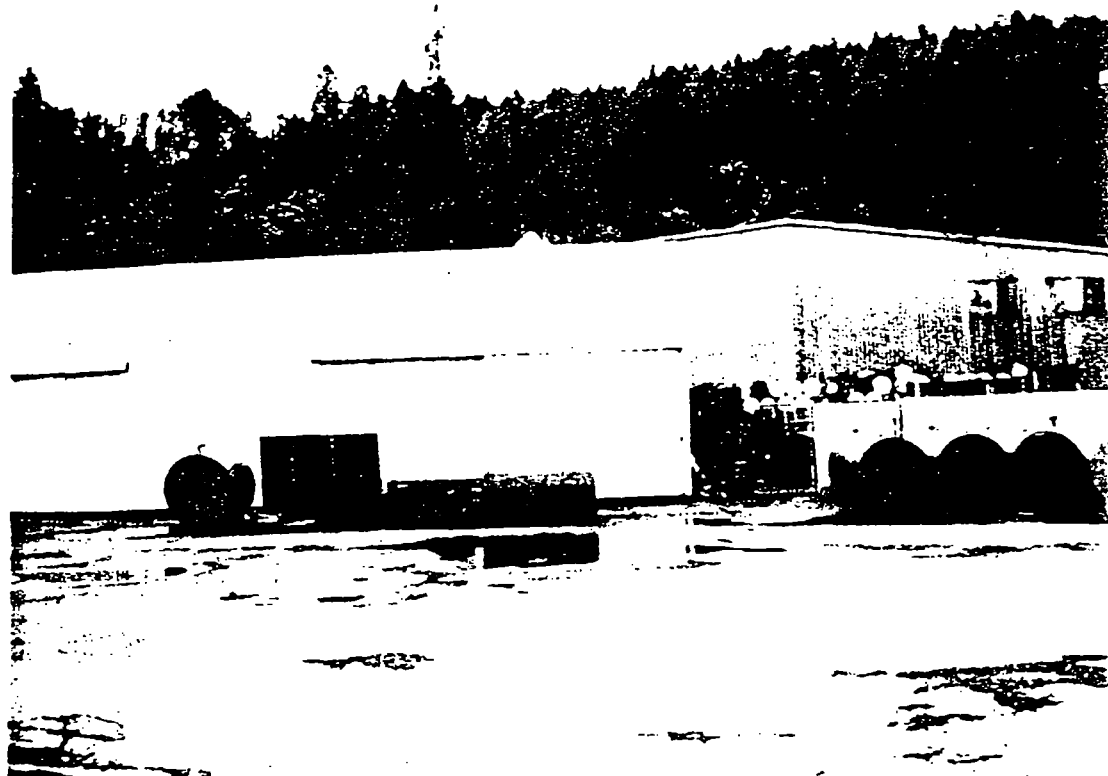
PHOTO 15

- 14) Photo looking south. Close up of some of the drums lining the fence. Note the blue drum on the right has been hand labelled "hazardous waste".
- 15-16) Panorama to the west. The Carson Oil storage shed is to the left in photo 15. The back portion of the MCC property is in the background in photo 15 and along the fence in photo 16. Note the staining on the silver AST located on the MCC property in photo 16.

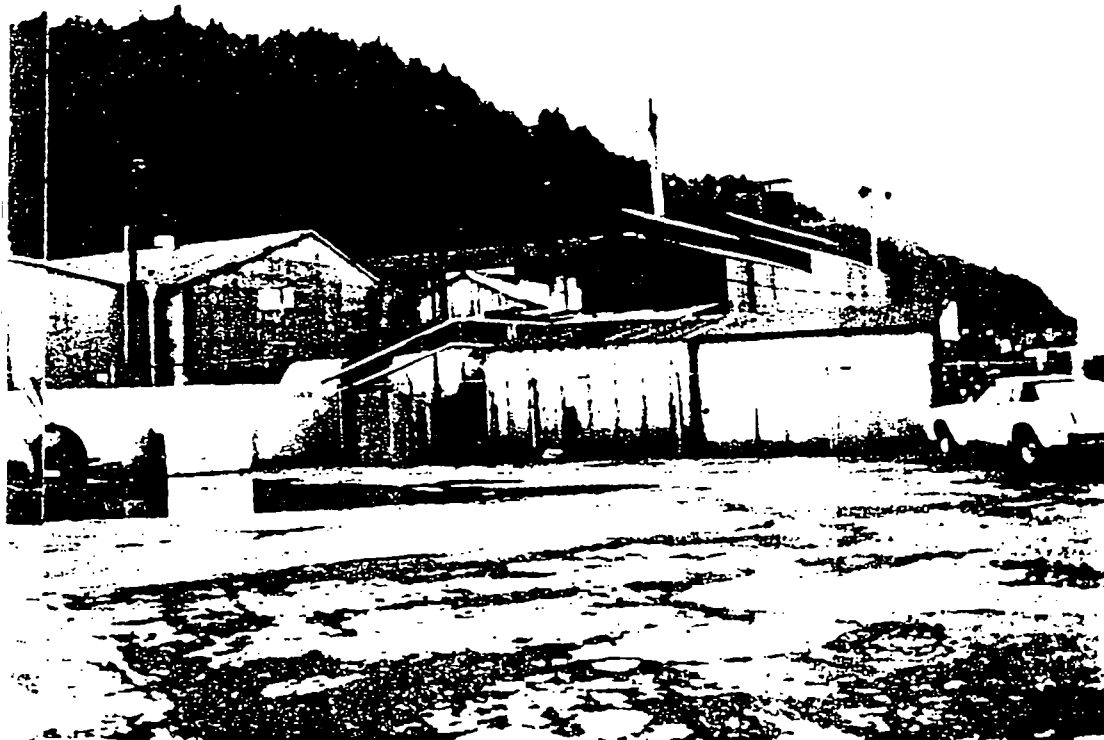
PHOTO 16

There is an approximately 5,000 gallon AST located on the MCC property which is located immediately adjacent to the subject property. There appears to be moderate to heavy petroleum staining on the AST and the soil under the AST (refer to photo 16).
